#### **COASTAL GEORGIA BROWNFIELD CASE STUDIES:**

From the Corner Lot to Former Industrial Sites

Stewart A. Dixon, P.G.

April 2017

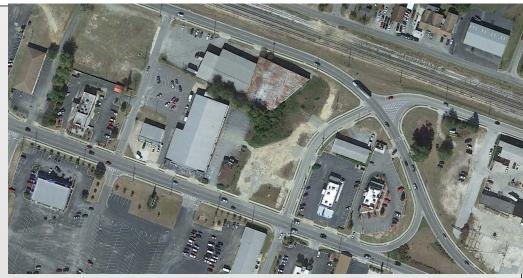
Vidalia

- Former Industrial Site (Early 1990s)
- Railroad Spurs
- Auto Repair (1970s mid-2000s)
- Dry Cleaner (1980s 1990s)
- Restaurant (1988 late 2000s)

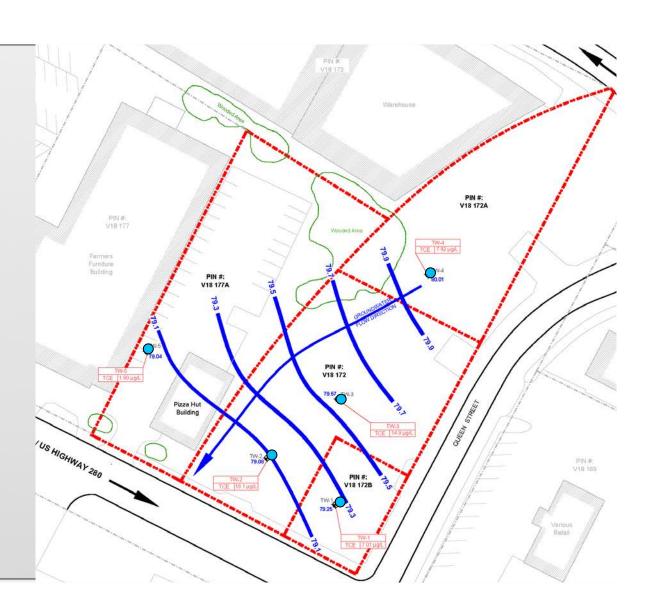
Vidalia

- Phase I ESA with Soil & Groundwater Sampling
  - VOCs
  - SVOCs
  - RCRA Metals
- No Detections of VOCs / SVOCs in Soil
- Trichloroethylene detected in all 5 Groundwater Samples
  - 2 ppb to 18 ppb

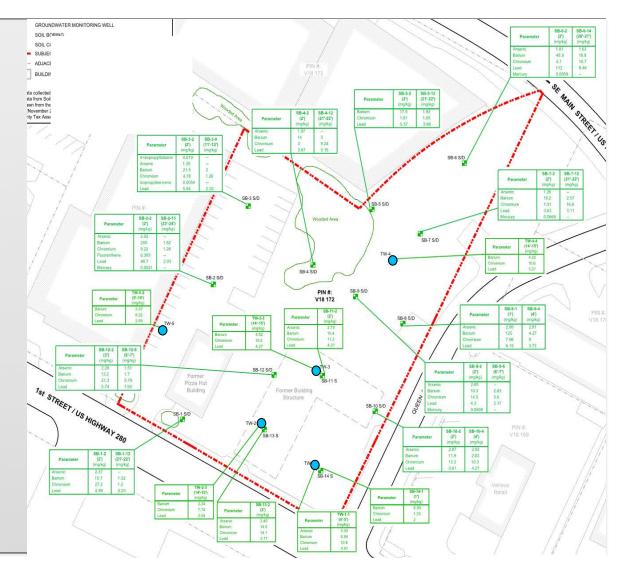
Vidalia

- Develop site investigation plan
  - Soils only (surface / subsurface)
  - Submit to EPD for approval
- 14 additional soil samples
- No VOC, SVOC, RCRA Metals detections above non-residential limits

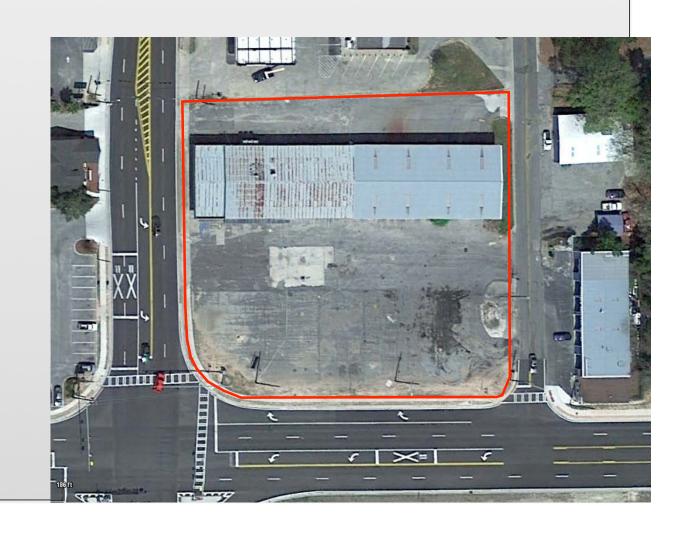
- Residential
- Auto Sales / Service
- On-site USTs
- Oil / Water Separator
- In-ground Hydraulic Lifts
- Prior Consultant Work
  - o 2015 Phase I ESA
    - No RECs
  - 2015 Limited Sampling
    - No detections in soil

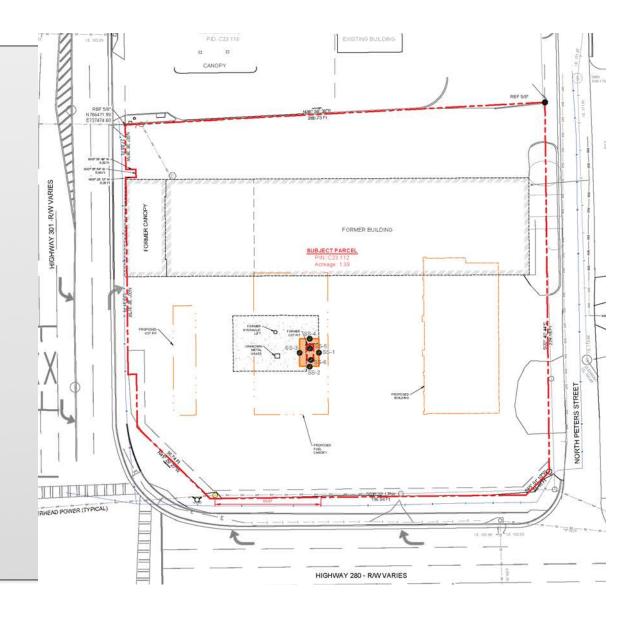
Claxton

- Client begins redevelopment immediately after closing
- Previously unknown UST found during site construction

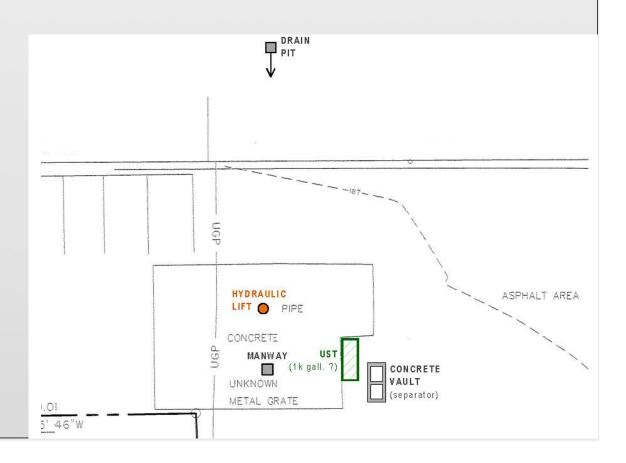
Claxton

- Soil impacted above Regulatory Limits by UST
- Soil contamination found 25 days after closing

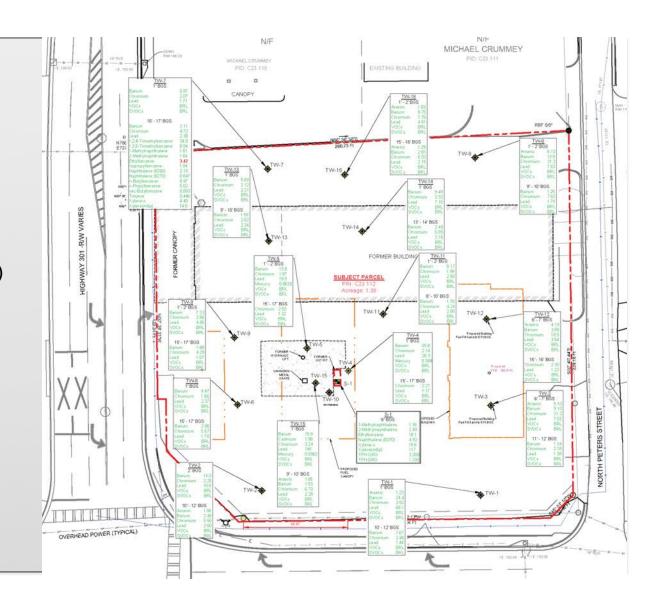
Claxton

- Site investigation work
- 16 soil borings (shallow & deep)
- 16 groundwater samples
- Removal of UST & in-ground hydraulic lift
- Aggressive sampling plan / network to limit construction delays
- New buildings & infrastructure

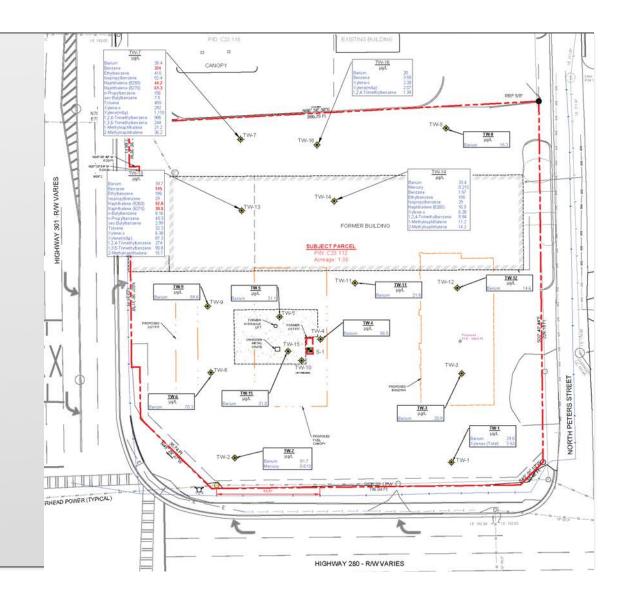
Claxton

- Site investigation work
  - Limited soil detections above regulatory limits outside UST Pit
  - Limited groundwater detections above Regulatory Limits
- Over excavation of UST pit
- Site construction resumed in less than 2 weeks

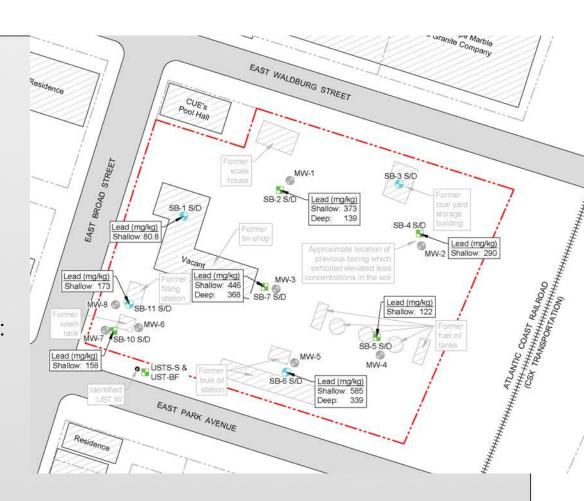
#### **East Broad Street**

- Lead in soil above Type 1 & Type 2
   RRS in both shallow & deep samples
- Type 2 RRS for Lead calculated using:
  - IEUBK Model
  - EPA Soil Screening Level Equation 10
- Additional delineation samples collected to define excavation limits

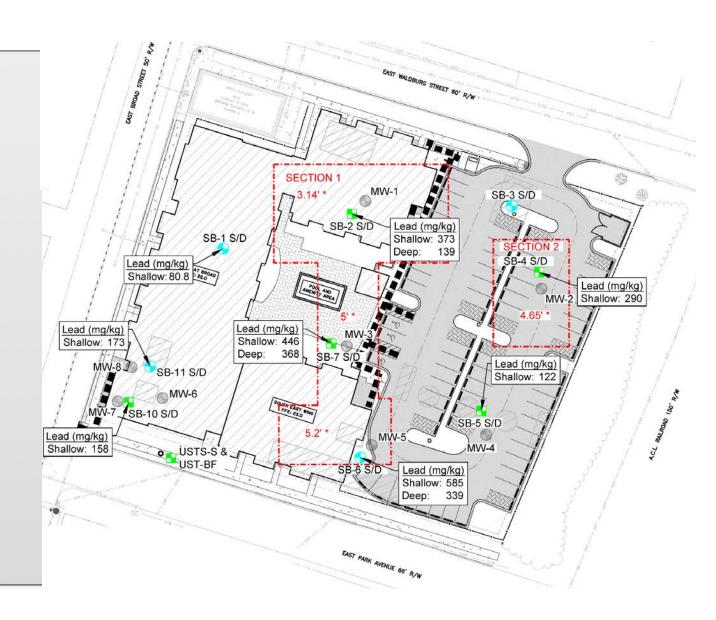
# **East Broad Street**

- XRF used during excavation
- Final laboratory confirmation sampling
- 3,600 tons removed & disposed of at subtitle
   D landfill

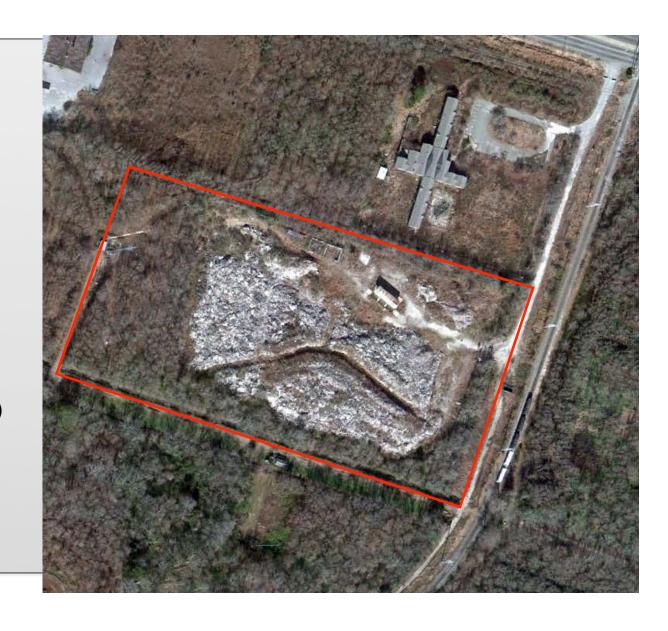
- 9 acres
- Filled with concrete waste from old Talmadge Bridge
- Former inert landfill (1990)
- Materials recovery facility (1998)

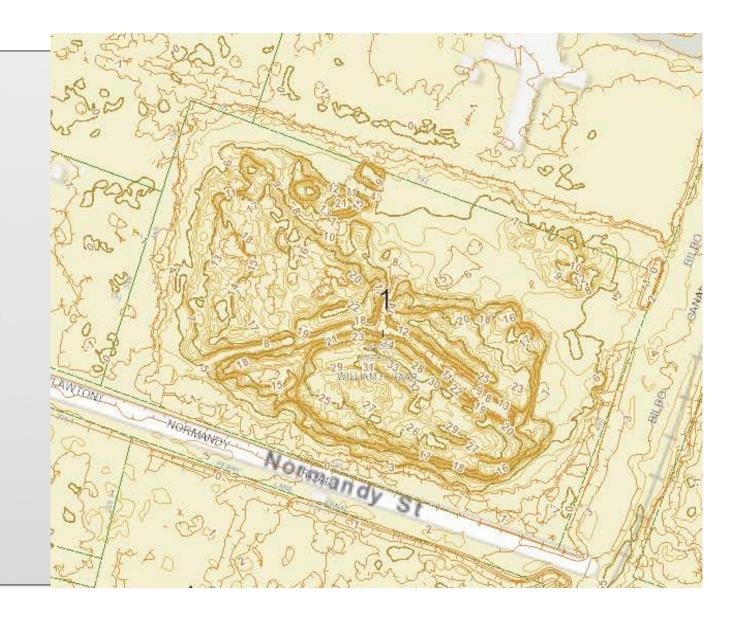
Savannah

Fill clearly evident on topo

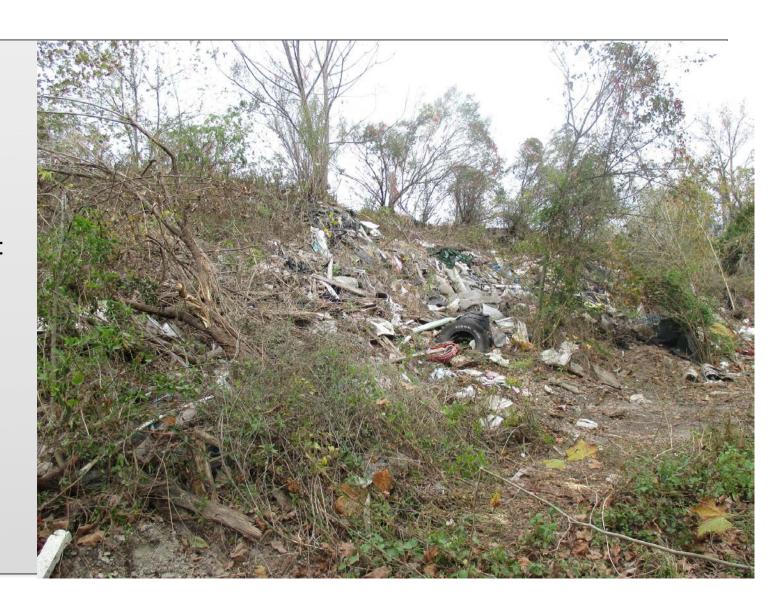
Savannah

- Debris includes:
  - Concrete
  - Wood
  - Metal
  - Plastic
  - Roof shingles
  - Wall board
  - Card board

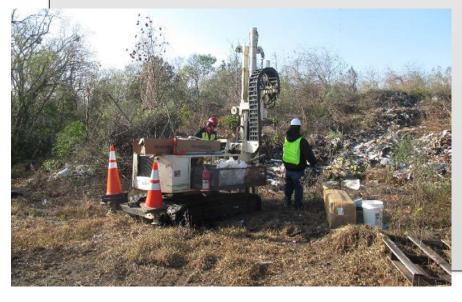
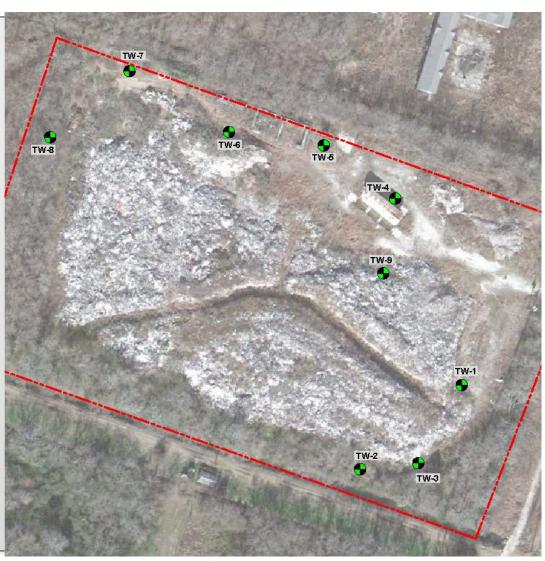
- Phase I ESA 2016
- Soil & groundwater sampling

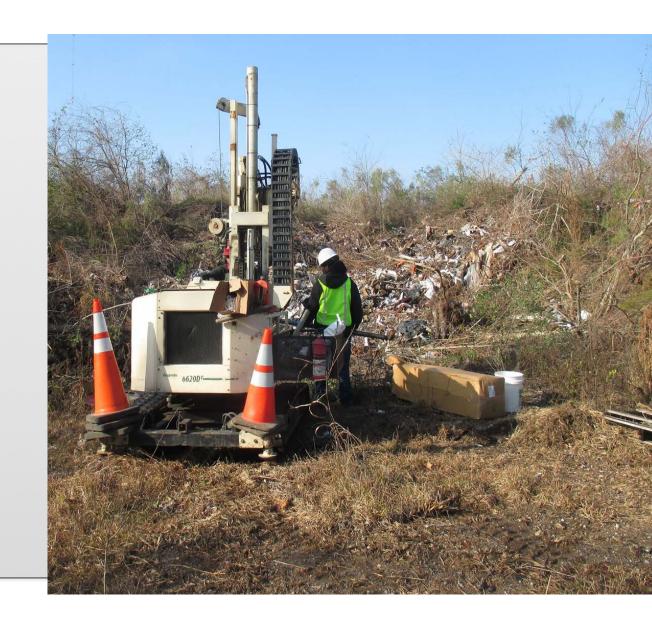
Savannah

- Soil exceedances above HSRA Notification Criteria
  - Carbon disulfide
  - Benzo(a)anthracene
  - Benzo(a)pyrene
  - o Benzo(b,k)fluoranthene
  - o Indeno(1,2,3-cd)pyrene
  - Bis(2-ethylhexly)Phthalate

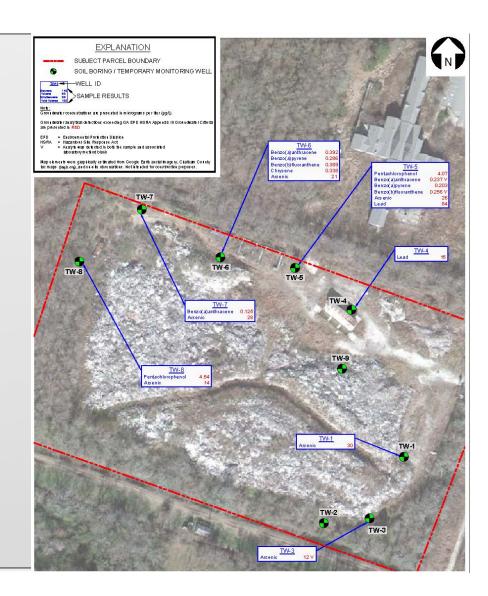
Savannah

- Groundwater exceedances above HSRA Notification Criteria
  - Arsenic & Lead
  - Pentachlorophenol
  - o Benzo(a)anthracene
  - Benzo(a)pyrene
  - Benzo(b)fluoranthene
  - Chrysene

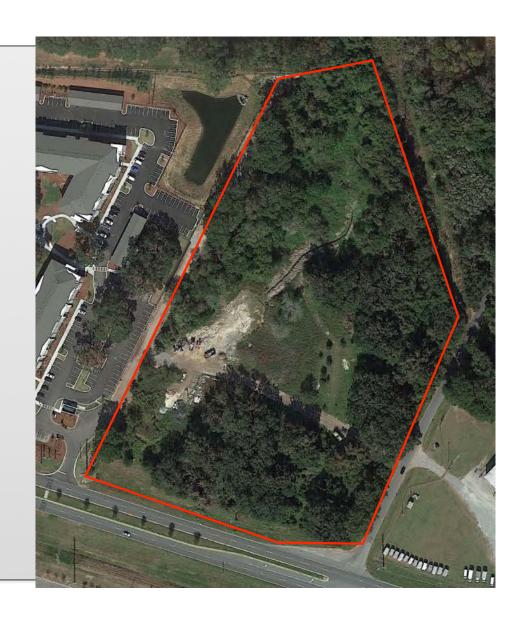
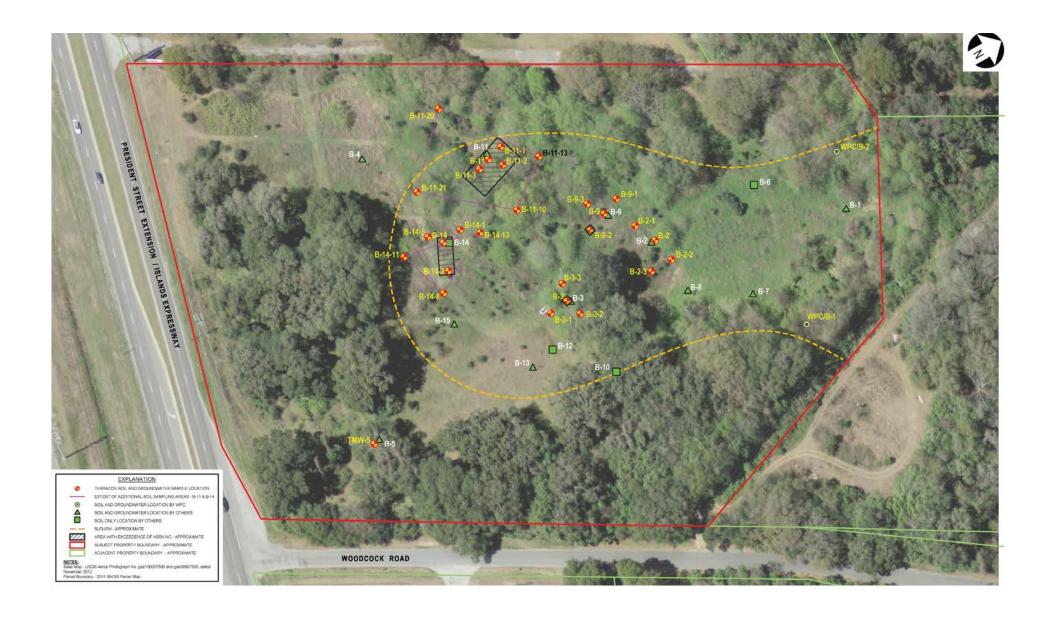
- 10 acres
- Historically undeveloped
- Site filled with bricks, concrete, wood, plastic, tires, & metal
- PAH impacted soils above HSRA Appendix I NC
- No known release to groundwater

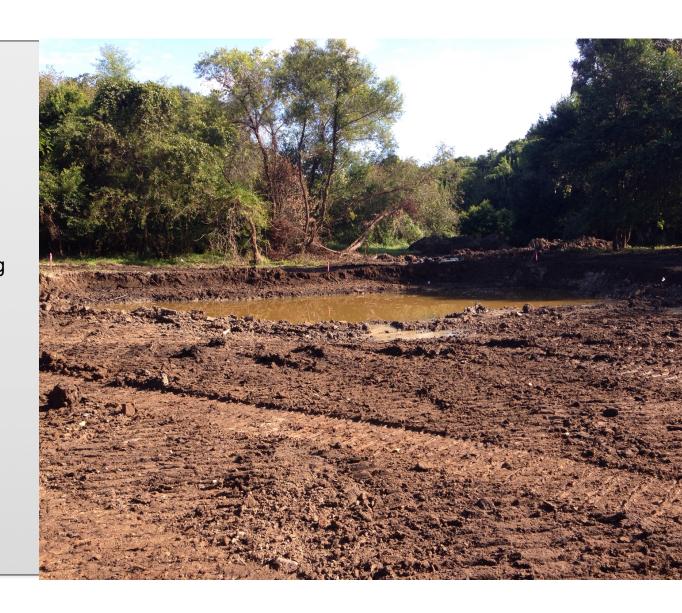
- Release Notification requesting listing deferral submitted
- Remediation of impacted soils completed
- 4,200 tons removed
- Corrective Action Report with HSRA Non-listing documentation submitted

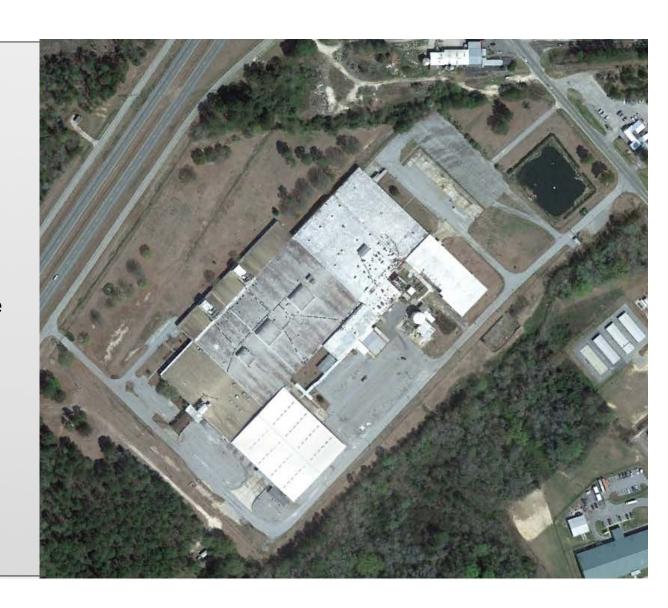
#### **Former SYS Plant**

- Site developed in 1969
- Carpet yarn processing
- ASTs, USTs, hazardous waste storage, wastewater aeration basin
- Historical releases in soil & groundwater of:
  - VOCs
  - SVOCs
  - Metals

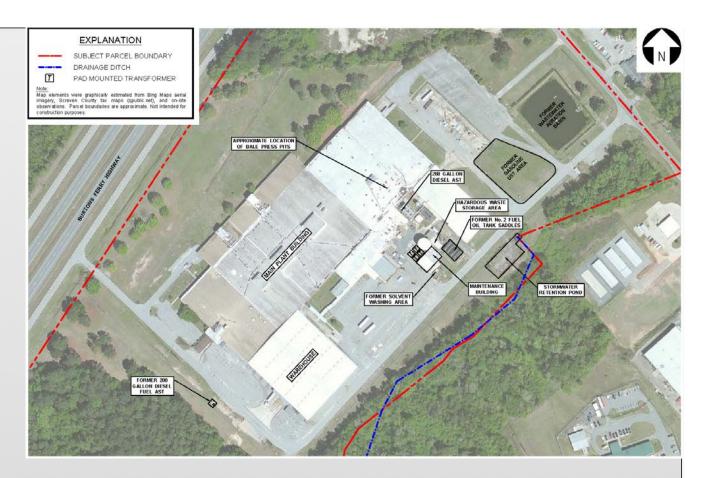
# Former SYS Plant Sylvania

- 7 potential source areas
- Previous work at site:
  - Soils certified to Type 2RRS in 2005
  - Groundwater certified to Type 4 RRS
- Plant continued to operate from 2005 to 2009

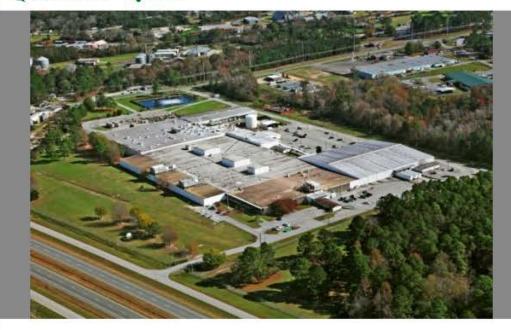
An aerial view of the former Sylvania Yarn Systems building that is being renovated for ELK Group International in Screven County. (Photo courtesy Screven County Economic Development Authority)
