GIS & GPS

To Facilitate Property Transfer

Fort McPherson, GA

Fort McPherson Former Crematory Site

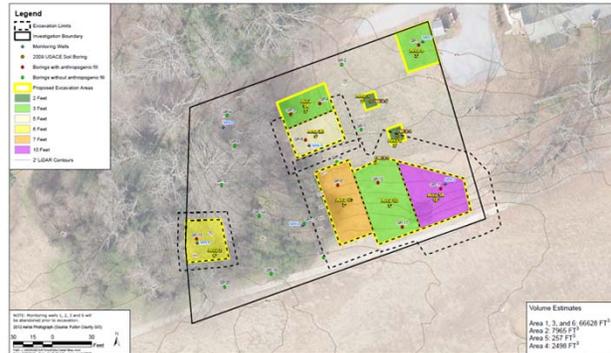
Speaker #1: Previous operations at the Former Medical Crematory Site (approximately 1.8± acre) resulted in buried ash, debris and soil containing elevated lead and dioxins that required removal and off-site disposal under an Interim Removal Action (IRA) prior to transfer to MIRLA.

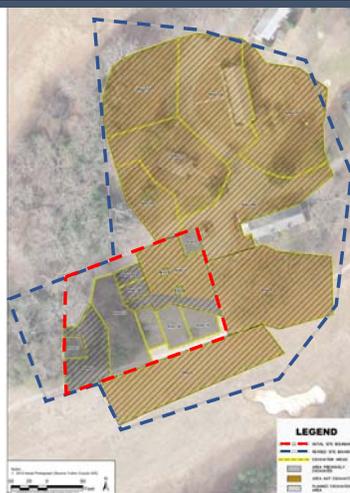
Speaker #1: During the IRA, additional impacted materials were discovered, and the site expanded from 1.8 acre to over 4 acres, immediately creating concern for the customer regarding the planned property transfer.

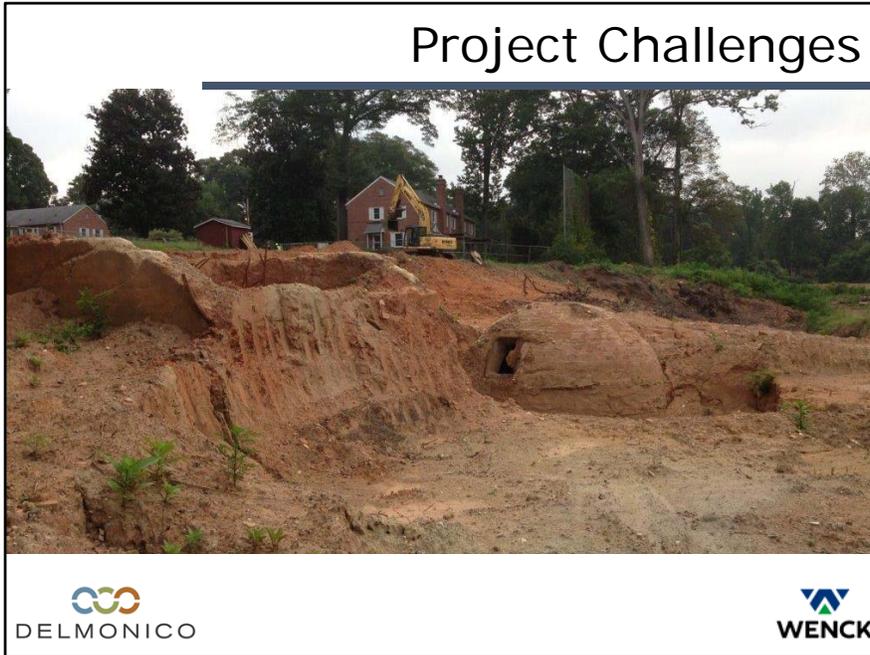
- Additional Site investigation was conducted with a trackhoe.
- Debris really wreaks havoc with drilling or direct push techniques
- Even though some anomalies were identified during previously conducted electromagnetic surveys, we uncovered large structures that were buried just beneath the surface.
- The electromagnetic surveys showed an enormous amount of debris and I believe the amount of debris and trash present interfered with the definition and extent of the underground structures.
- These structures were either missed or underestimated during previous investigation work.
- This picture shows a brick cistern that was part of the old water system.
- The GIS / GPS allowed us to record real-time location and extent of these structures for future reference

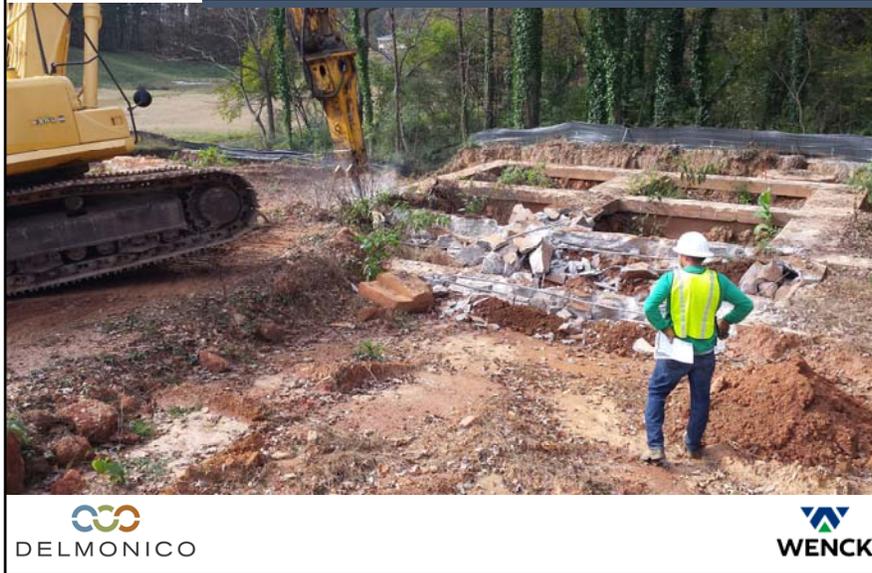
- This picture shows the foundation of old water treatment plant structures, either tanks or buildings.
- The site had been graded and these structures were buried during this site grading.
- It was surprising to see such large structures uncovered during the excavation when drill rigs had previously sampled all over the site.
- GIS/GPS was used again to document the location and extent of these structures and to document accurately the location of samples taken to confirm all contamination had been removed.

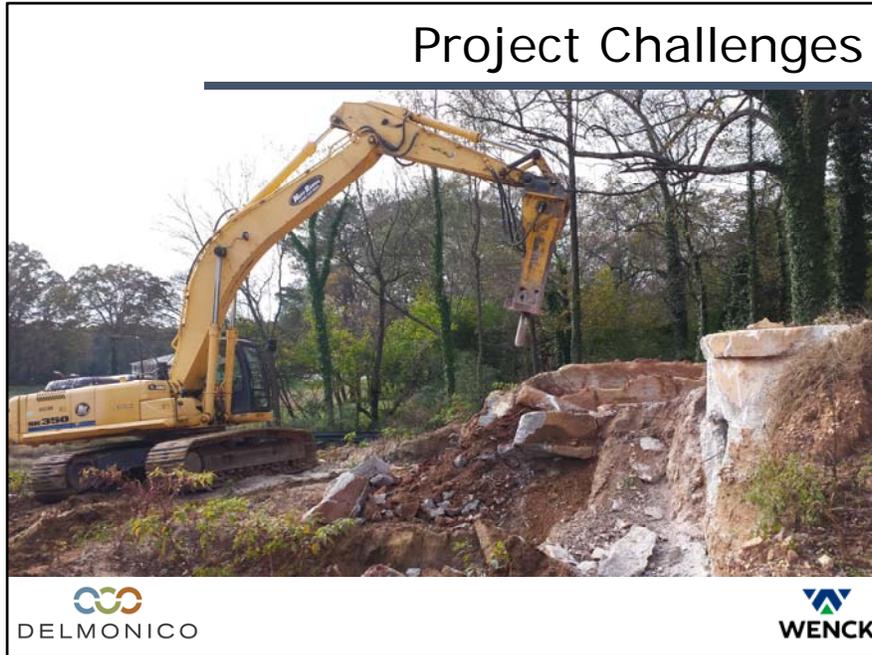
- This is another example of the sorts of structures uncovered that had to be demolished during the course of work.
- Our site investigation showed that contaminated material had to be removed to a certain elevation and these structures had to be removed to that elevation so that site restoration could occur.

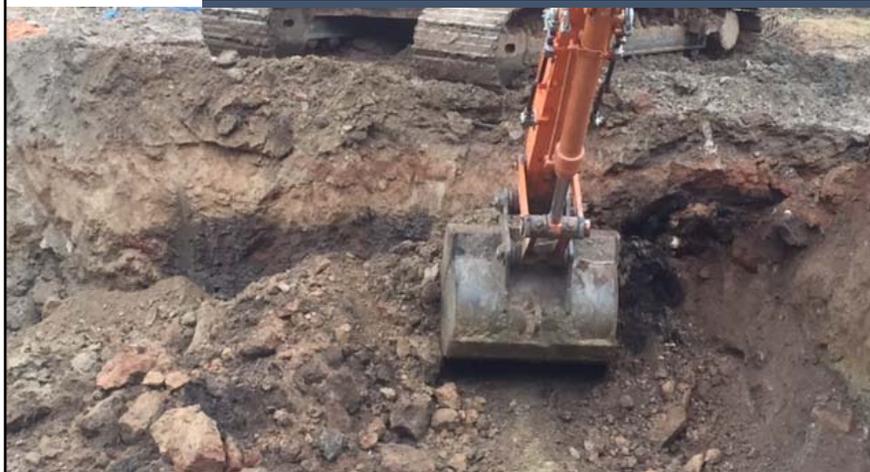
- The site investigation showed that several feet of clean overburden existing above the contaminated material.
- This picture shows an example of just such an area.
- See the clean soil in this picture above the stained layer of material.
- The GIS/GPS was used to document and track the location of the clean overburden.
- Allowed us to plan our excavation work and minimize the over-excavation of clean soils resulting in less material being hauled off site for disposal – remember this was a Firm Fixed Price Contract.

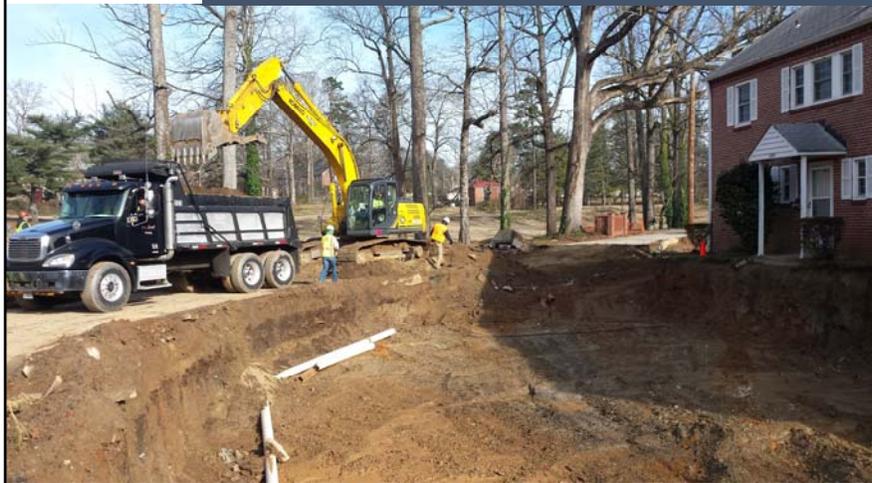
- This picture shows how the contaminated materials extended into areas adjacent to and under buildings on site.
- The GPS was used to record sample location as well as road and utility locations.
- This data was later used to perform planning and site restoration that included utilities put-back.

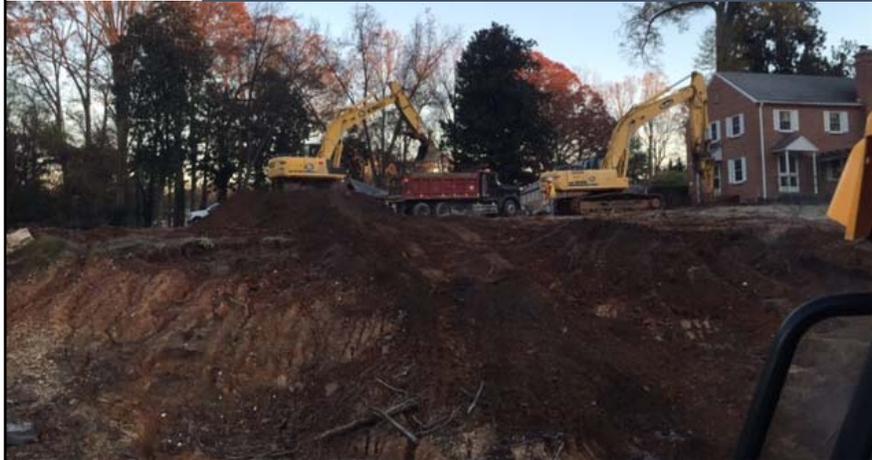
- This picture shows the load out excavated contaminated materials.
- We used a day-pile approach to efficiently handle materials and allow for continuous load out even during bad weather.
- The GPS was used to document the location of our load out area, it changed a few time throughout the project,.
- We recorded where the confirmation samples were obtained and eliminated redundant sampling and analysis.

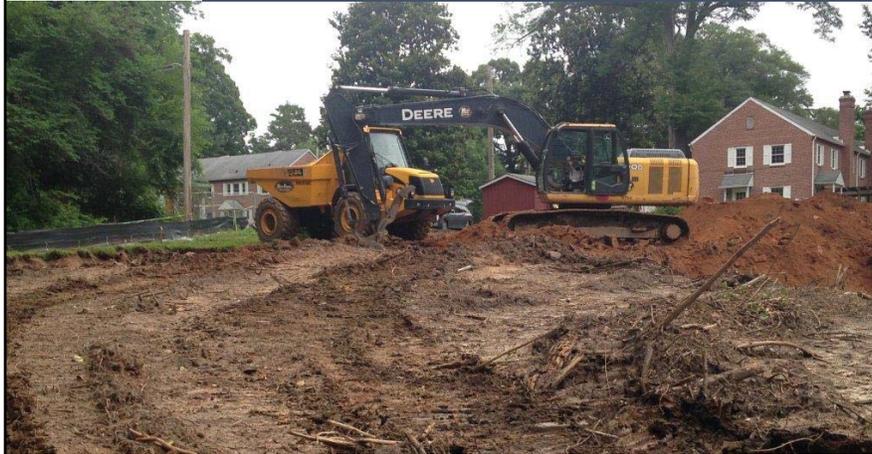
- This is a picture of our temporary haul road during the first phases of the project.
- We made sure we placed this haul route on known contaminated areas so that we did not drag any contaminated materials onto clean areas.
- We used the GPS to accurately location the extent of excavation and then plan our day to day operations and material handing effectively with confidence in our plan
- We minimized any cross contamination with the use of the accurate GPS

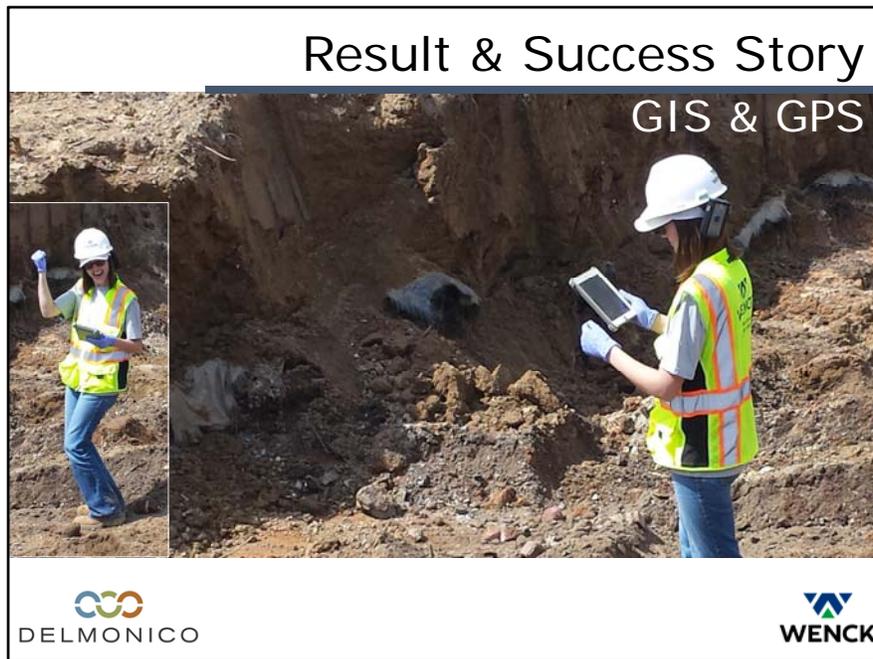
- This is a picture of our field technician using the GPS and hand held tablet with GIS interface
- Under ideal conditions, smart device technology has a positioning accuracy of 5 to 6 meters, under ideal conditions mind you – cell tower triangulation, data access, etc.
- Using the GPS device that we used, a Trimble R1 GNSS receiver, we increased that accuracy by a factor of 10X, down to a half meter (about 20 inches!!)
- She does not like the inset picture I have included on this slide, but I love it it shows a genuine spontaneous reaction to accomplishing a mission with effective and useful tools, and I think it shows an enthusiasm for her work that comes with a job well done.
